Structural Failure in Building Fires - Lessons Learned from 9/11

J. R. Barnett, Ph.D., CPEng, FSFPE

ABSTRACT

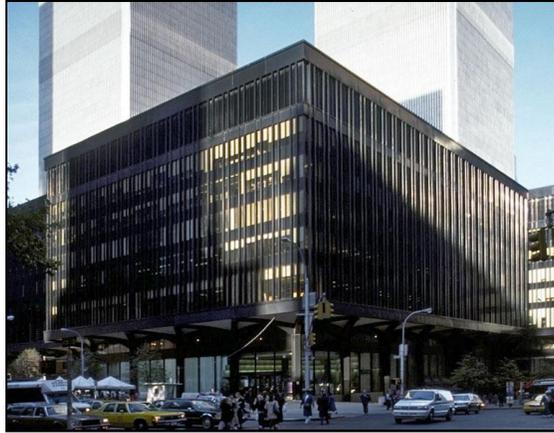
Figure 1. WTC 5.

As reported by ASCE/FEMA (2002) the nine-storey (see Figure 1) steel framed building’s floors consisted of 0.1 m (four-inch) thick lightweight concrete fill on metal decking. Floors five through eight used a Gerber Beam design consisting of a 1.22 m (four-foot) long beam stem shop-welded to a column, forming a column tree, with a simply-connected floor girder bolted to the beam stem using shear tabs. A typical section is illustrated in Figure 2 (LaMalva, 2007). The Gerber beam design was developed by Gerber in the 19th century and locates structural hinges at inflection points to allow settlement without an increase in the maximum bending stress (Schierle, 2011). The main advantage of the Gerber design is that the high cost of field erected moment splices is avoided and the reduced depth of the girder allows for easy routing of building services without the need to penetrate structural webs. This design approach was popular in the US through the 1970s. There appears to have been a worldwide resurgence of the Gerber beam design in recent years, due to the changing cost of steel construction. However, there is no indication that Gerber beams have been used in Australia.

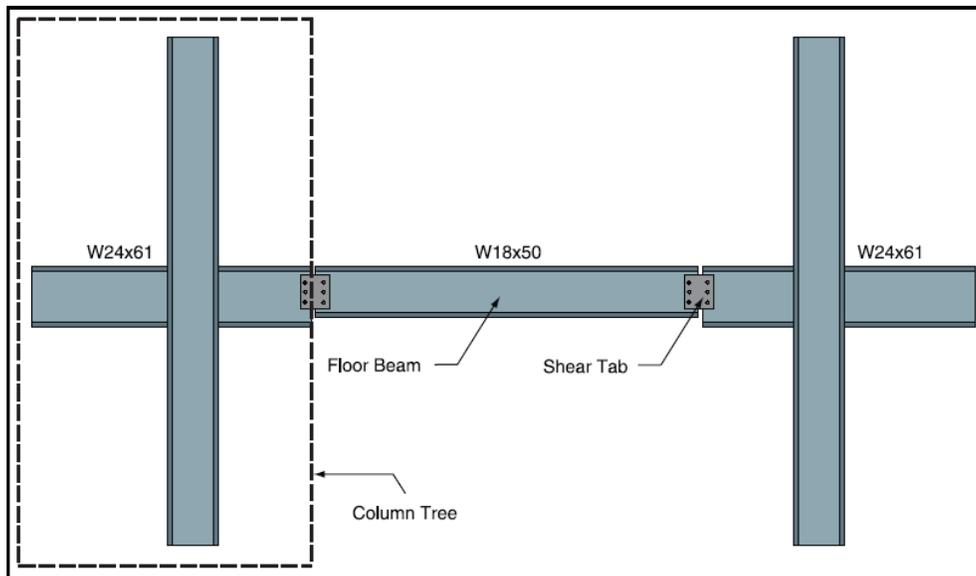
Figure 2. Typical Gerber beam configuration (not to scale).

The areas of WTC 5, which did not collapse, used more conventional systems consisting of either a moment frame or girders resting on column seats bolted directly to a column. The steel framing was protected against a fire's heat energy impact by a sprayed vermiculite coating (Grace Monokote MK-5). The coating thickness was designed to provide the structural adequacy component of the fire resistance level (FRL)¹ of 3-hours for columns, and 2-hours for girders, beam stems, shear tabs and the concrete slab.

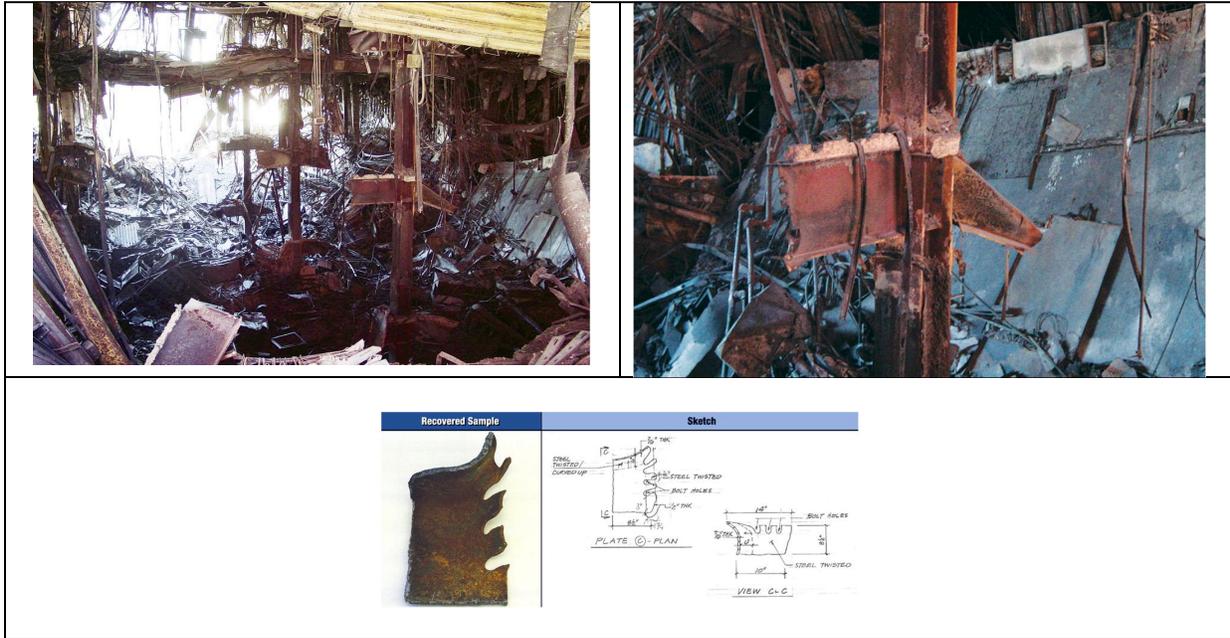
Figure 3. Column Tree Failures

As illustrated in Figure 3 (ASCE/FEMA, 2002) the column tree failure was extensive. As observed by the author during a visit to the site, the failure was due simply to the fire as there was no evidence of impact damage in the vicinity of the collapse. This failure raised two major questions,

The forensic evidence suggested that the building was compliant with the fire protection requirements of the local building code at the time of construction; areas where the spray on vermiculite protection was in place were protected with appropriate amounts and types of insulation. Likewise, because the columns remained plumb after the collapse, there is a strong likelihood that the collapse occurred during the heating phase of the fire. If it had occurred during the cooling phase, during uneven temperature and loading conditions, it is more likely than not that the columns would not have remained plumb. The author implemented a research program to determine if this qualitative assessment could be verified.

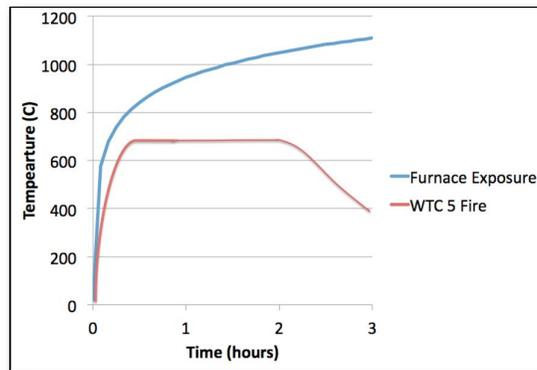
Figure 4. Time-Temperature Exposure

Fire Prediction. Using information gathered by ASCE/FEMA and NIST, and computer fire modelling using CFAST, LaMalva predicted the average time history of the fire in WTC 5. This is depicted in Figure 4 where it is compared to the standard furnace time-temperature curve used in AS 1530 Part 4. Of interest is that the predicted peak temperature of the actual fire occurs at 12 minutes exposure in the AS 1530 furnace fire.

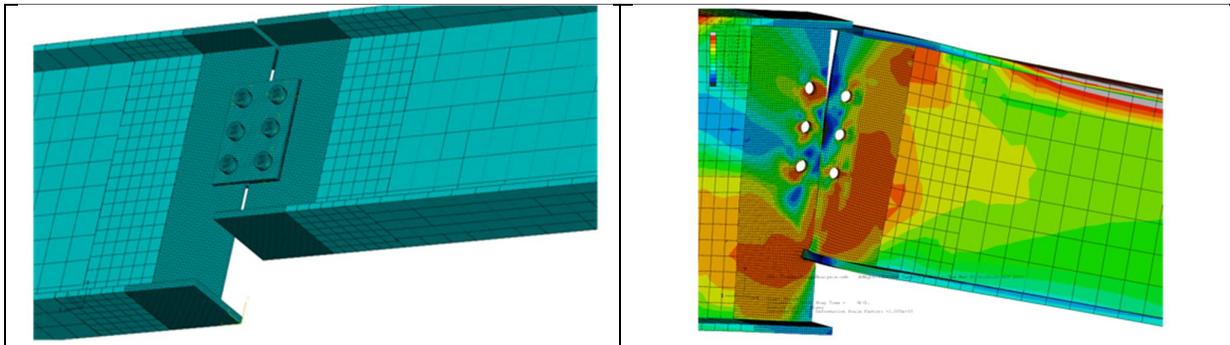
Figure 5. ABAQAS Finite Element Mesh

Structural Response. Using the finite element mesh depicted in Figure 5, LaMalva used ABAQUS to predict the time to failure of the shear tab connection between the girder and the beam stem using a sequentially-coupled, thermal stress model. After modelling the transient behaviour of the shear tab exposed to the WTC 5’s temperature the ABAQUS results are presented in Figure 6. The maximum predicted average steel temperature was 450 °C. The predicted temperature at the boltholes was 660 °C. The stress levels at the boltholes indicated imminent failure. At this point in time the maximum plastic shear strain at the top bolthole was predicted to be 0.47. Therefore, the thermal-stress model predicted a “runaway” bolt rupture failure at approximately two hours of fire exposure, during the heating phase of the fire. In addition, a qualitative comparison of the predicted deformations matched the deformations observed in the samples collected at the site.

Analysis. The structural failure in WTC 5 occurred at much lower fire temperatures than would be expected for a protected steel system. The failure most likely occurred at a fire temperature of 700 °C whereas for the case of a structure with an FRL of 2-hours, the fire exposure temperature would be 1049 °C. This is primarily because the failure was due to a failure at the connection of the girder to the beam stem, not a failure of the girder itself.

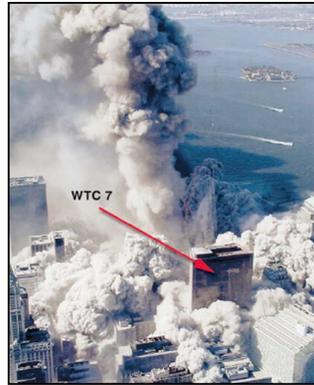
Figure 7 - WTC 7 in the dust cloud from the collapsing WTC 1 tower

WTC 7 was a 47-storey office (see Figure 7 (ASCE/FEMA, 2002)) building completed in 1987. It was roughly trapezoidal in shape with a length of 100 m on the north, 75 m on the south and 45 m wide. It had an unusual design as the original plan was for a much smaller floor area. Caissons were installed for this original design around and through a large subsurface electrical substation. The final design required a unique structural framing grid to transfer the load to the original caissons. The superposition of the original foundation plan with the final one as well as the resultant unsymmetrical typical floor-framing plan is shown in Figure 8 (ASCE/FEMA, 2002).

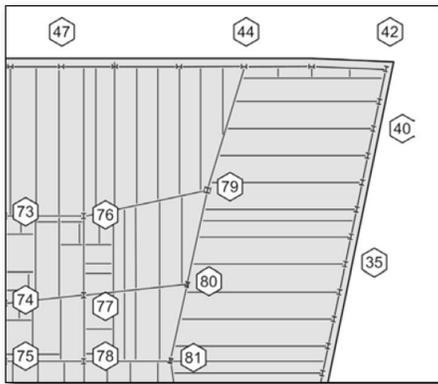
Figure 9. Framing Near Column 79

The initial fires in WTC 7 started near the south façade and with time progressed in a clockwise direction around the building. By about 4:00 p.m. the fire had reached the east end of the 13th floor. The structure in this portion of the building was protected with a sprayed vermiculite coating, which provided an FRL of 3-hours for the columns and 2-hours for the beams (ASCE/FEMA, 2002). This eastern end of the building was the location of column 79. As illustrated in Figure 9, the framing into column 79 consisted of two roughly north-south pointing girders and two east-west girders. If we consider the girder spanning between column 79 and column 80 we note that there are long

beams framing into this girder supporting the floor slab towards the exterior façade to the east. This is similar to the situation between column 79 and column 44. As the fire progressed to this portion of the floor plate, these long beams expanded, pushing against the girders between columns 79 and column 80 and between column 79 and column 44. Unlike a normal Cartesian framing system, there were no beams framing into these girders to the west. Therefore, the only mechanism to keeping the girders on their column seats at column 79 were simple connections consisting of a shear plate and a couple of bolts. This connection was not designed for the stress caused by the thermal thrust from the beams framing into the girders. Computer analysis using ANSYS predicted that with temperatures as low as 400 °C these simple connections would fail and the beams would push the girders off the column 79 supports. NIST’s study showed that a failure of this type on the 13th floor would lead to a general cascading failure resulting in the disproportionate collapse of the building. This is illustrated in Figure 10 showing an LS-DYNA simulation of WTC 7 (Gann, 2008).

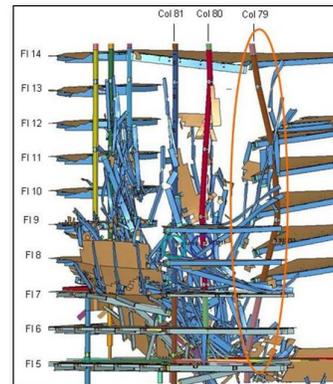
Figure 10. Predicted Collapse Around Column 79

Failure in AS1530 Part 4 is normally considered to occur with an average beam temperature or a column temperature greater than 538 °C. In WTC 7 column 79 most likely buckled when its temperature was less than 300 °C. The failure, due to thermal expansion of girders and beams and the resultant lack of frame stability, is not predicted by the test standard.
