Investigative Research on Bridges Subjected to Tsunami Disaster in 2011 off the Pacific Coast of Tohoku Earthquake

H. Kasano*, J. Oka*, J. Sakurai*, N. Kodama*, and T. Yoda*

ABSTRACT

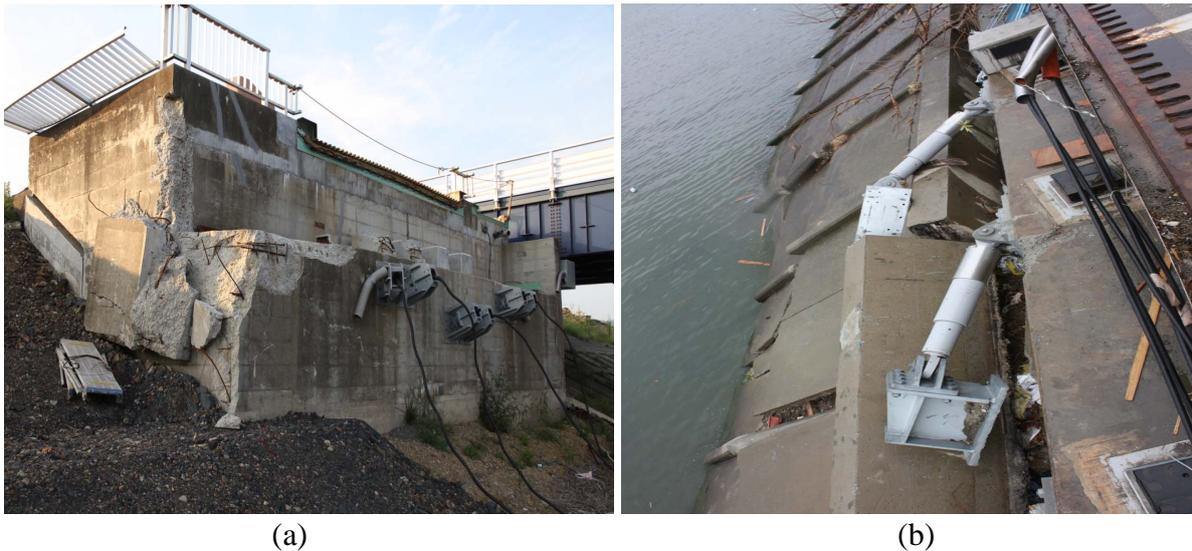
Figure 2 shows the fall-off prevention devices destroyed by tsunami waves. The wave force of tsunami can easily tear off the connectors of fall-off prevention device which are strong enough to carry the dead load of the bridge itself. Therefore, the fall-off prevention devices are almost useless to prevent the bridge from being washed away by the large tsunami waves.

Figure 2 Fall-off prevention devices tore off by tsunami waves;
(a) Kitagami bridge (Long.; 141.423077 E., latitude; 38.547058 N.)
(b) Kesen biridge (Long.; 141.618096 E., latitude; 39.010101 N.)

- 1) There is less possibility that fall-off prevention devices can prevent a bridge from being washed away by such massive tsunami waves as were observed this time in Tohoku area.
- 2) Heavy concrete bridges are unlikely to be swept away by tsunami waves comparing to light steel bridges. The reason is simply considered to be due to the difference of inertia between the two types of bridges, which means that bridges with large mass have resistance to both lateral and vertical tsunami wave forces.
- 3) From the investigation, it was confirmed that the superstructure on the high piers was possibly subjected to the larger wave force than the one close to the ground level. Furthermore, the floating debris could give additional impact load on the superstructure located near the surface of the tsunami waves under the actual condition.

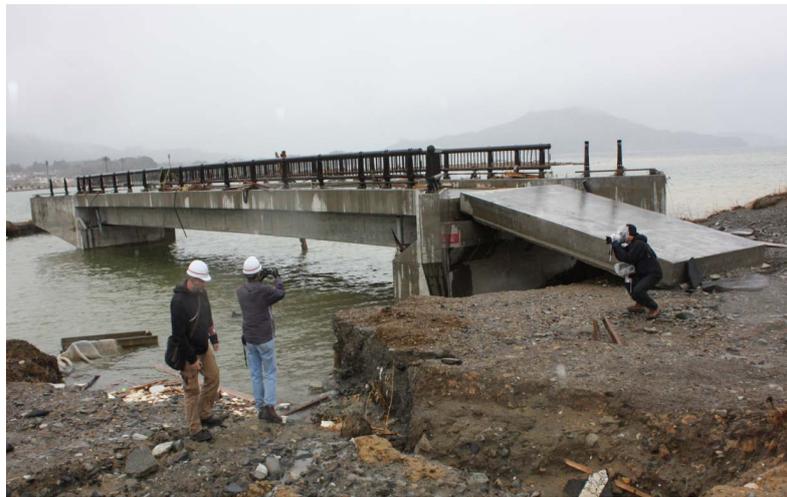
In regard to the height of bridge superstructure, the superstructures that were located in lower height from the ground level tend to withstand the tsunami waves. On the contrary, the superstructures on the high piers are likely to be washed away when subjected to the tsunami waves. Fig.5 shows Furukawa bridge which superstructure is set only about 1m high from the water level. And this bridge survived through the attack of tsunami waves even though it is located just near the seaside. On the other hand, heavy concrete superstructures on the high piers were removed by the tsunami waves as shown in Fig.6(a); the case of Numata-kosen bridge. Numata-kosen bridge is a multiple span simply supported prestressed concrete bridge. And as can be seen in Fig.6 (b), concrete deck fell down to the ground. There was a mark on the pole of gas station near this bridge, that indicates that the height of the tsunami waves was as high as the deck of this bridge. This fact is examined in the next section.

Figure 5 Furukawa bridge
(Long.; 141.630678 E., latitude; 39.008261 N.)

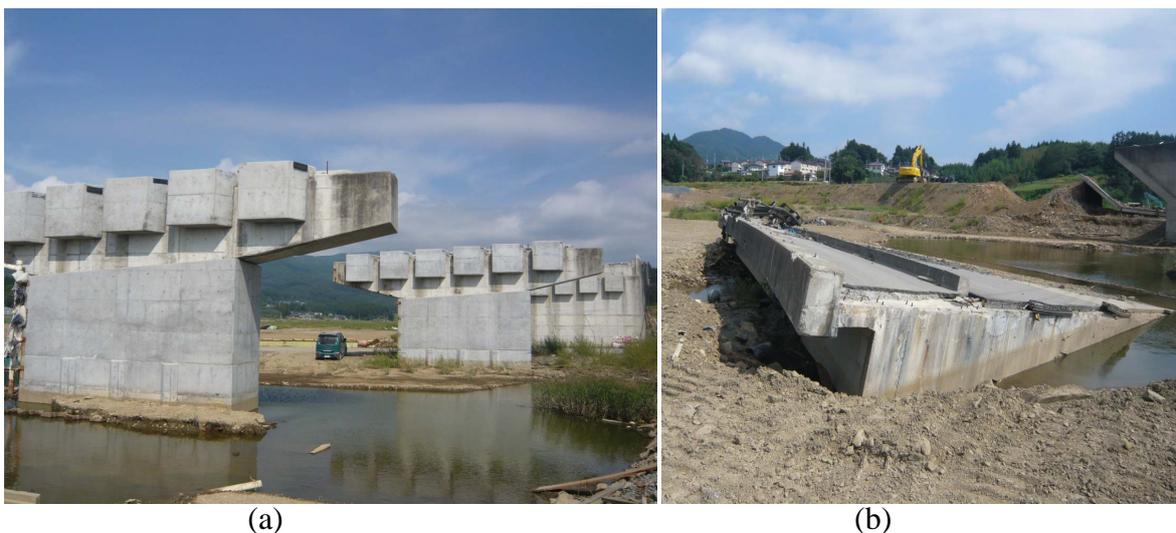
Figure 6 Numata-kosen bridge (Long.; 141.649598 E., latitude; 39.008795 N.):
(a) piers remained; and (b) concrete deck fell down.
