Axial compressive behaviour of circular hollow section (CHS) strengthened by prefabricated FRP jacket system

S.J. Kim*, L.J. Walker, * and R.J. Gravina**

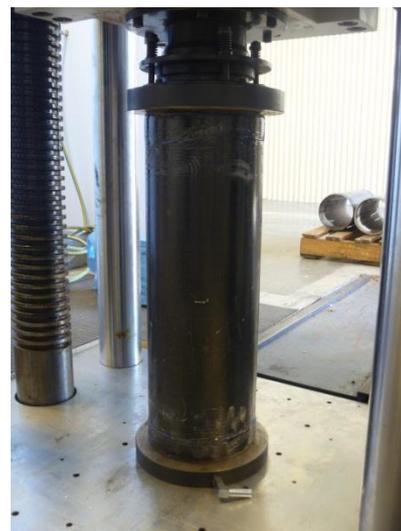
Figure 2. Test set-up

All testing was conducted in a universal testing machine of 3,000 kN capacity. The base test platen was fixed to a stiff reaction frame, however, the top loading platen was joined to a spherical seat was connected to the crosshead (Figure 2). All specimens were loaded to 15 kN at a load rate of 5 kN/min and then loaded to failure with a constant ram displacement of 1 mm/min. Applied load and crosshead displacement were recorded by digital data logging system throughout the tests.

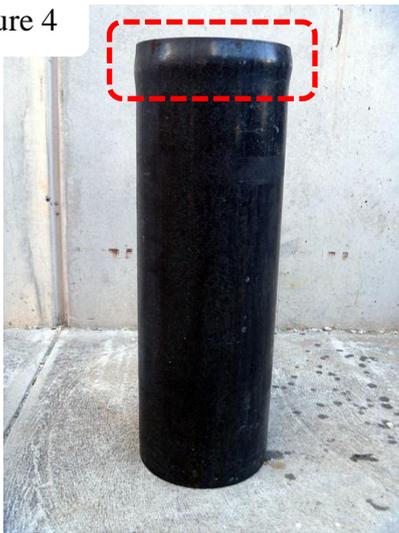
Figure 3. Failure of NS-C-1

All unstrengthened control specimens failed by typical buckling failure (i.e. elephant's foot buckling). A clear forming of a circumferential yield line was observed in both NS-C1 and SS-C1 specimens. For the normal section specimen, (i.e. NS-C1), the buckling failure occurred after experiencing a yield plateau (i.e. a large axial displacement with little strength increase) (Figures 3 and 4). The slender specimen (i.e. SS-C1) showed very little or no post yielding behaviour and

sudden strength loss just after the buckling failure. Such behaviour implies that the slender structure did not have a sufficient deformability.

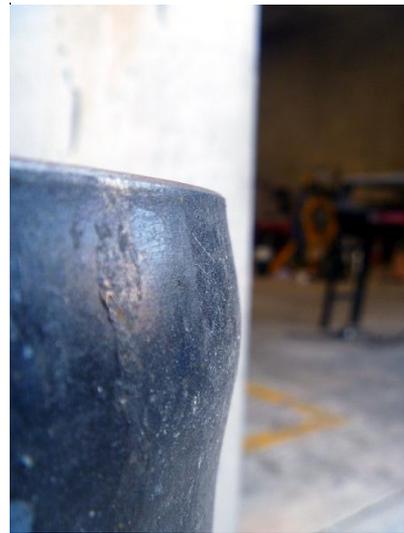
Figure 4. Failure of NS-C-1 (Detail)

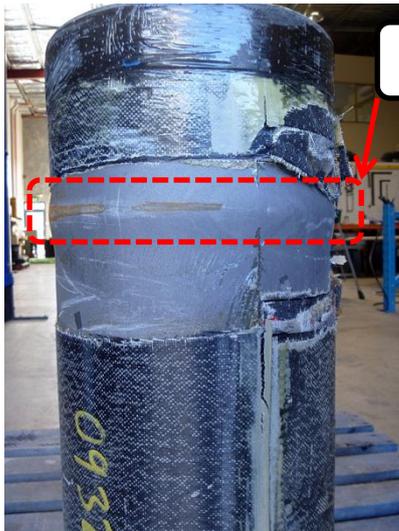
Figure 5. Failure of NS-J-1

The jacketed specimens with the normal section (i.e. NS-J-1 and NS-J-2) showed similar behaviour to that of normal FRP confined specimens (i.e. wet lay-up system specimens) (e.g. Teng and Hu 2007 and Jaedir and Zhao 2011). Localised failure of the jacket and wall buckling occurred at the same region just after reaching the peak load following a large axial displacement. Elephant's foot buckling was observed in NS-J-1 just beneath the failed jacket joint (Figure 5) and inward wall buckling also occurred in NS-J-2 at the same height of the localised jacket joint failure (Figure 6). It should be noted that only localised failure at the jacket joint occurred in the sample NS-J-1, however, a strip of the jacket was removed in order to observe the steel failure as seen in Figure 5.

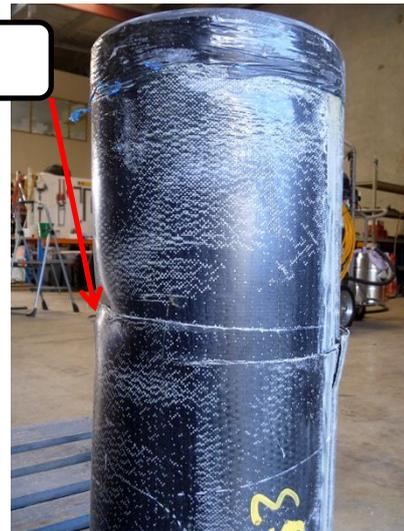
Figure 6. Failure of NS-J-2

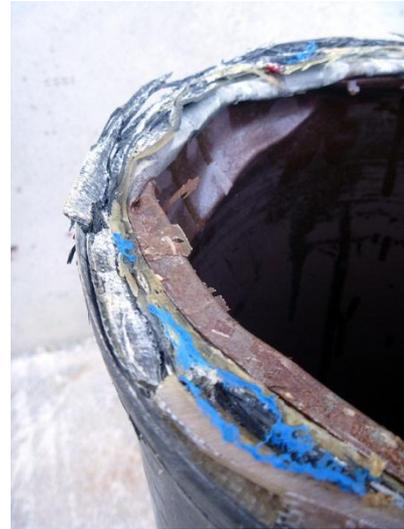
Figure 9. Failure of SS-J-1 (Detail)

All jacketed slender specimens (i.e. SS-J-1 and SS-J-2) showed localised crushing failure at the bearing region (Figure 8). The intentionally formed non-jacketed 5 mm bare steel collapsed vertically like a concertina and the failure kept progressing within the 50 mm strengthened jacket bearing region (Figure 9). The columns were still able to carry certain level of load during such local failure progress (approximately ranged 60 -90 % of the peak load) with high load fluctuation, however these results are not reported herein. No sign of failure in both steel and jacket system was observed in the testing region (Figure 8). It is the hypothesis that if such a localised premature
